Manhole Inspection Summary

Manhole # S49C__013MH

Insp Date: **6/11/08 12:51 PM**

Location Address: **200 n glover st**

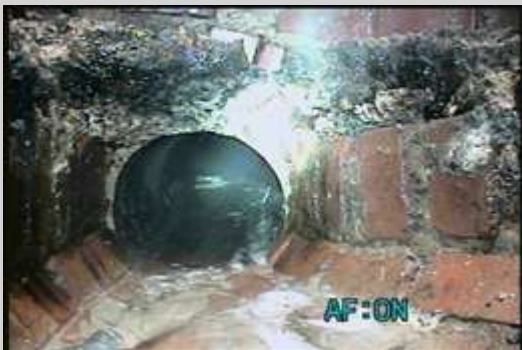
12 O'Clock Outflow

8 in. Circular Gravity Sewer
Pipe Out @ 12 O'Clock

Pipe Material: Clay ☐ Pipe Lined

Invert Depth: 9.80 (ft.) Flow Characteristics: Fast

Deposits: ☒ None ☐ Mud ☐ Sludge ☐ Debris ☐ Grease

Infiltration: None Pipe Seal Cond: Unknown

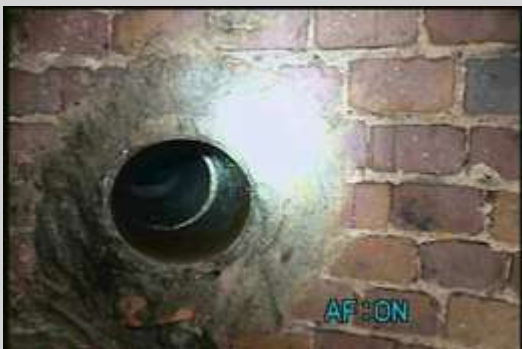
3 O'Clock Inflow

8 in. Circular Gravity Sewer
Pipe In @ 3 O'Clock

Pipe Material: Clay ☐ Pipe Lined

Invert Depth: 7.30 (ft.) Flow Characteristics: Fast

Deposits: ☒ None ☐ Mud ☐ Sludge ☐ Debris ☐ Grease

Infiltration: None Pipe Seal Cond: Unknown

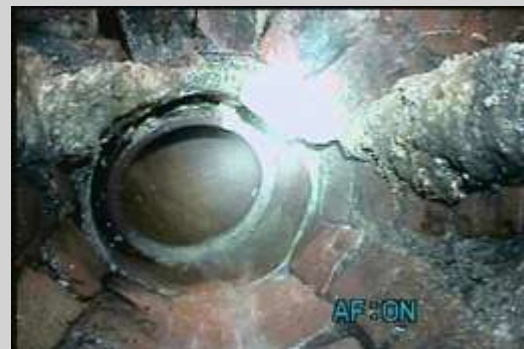
Drop In @ 3 O'Clock

Drop: Outside Direct

Inv Depth: 8.80 (ft.)

Drop Condition: Open

Connects To: House connection / Service line

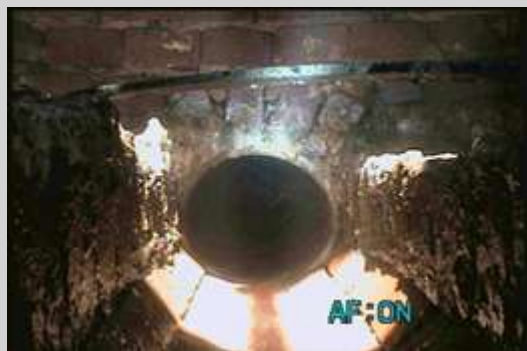
6 O'Clock Inflow

8 in. Circular Gravity Sewer
Pipe In @ 6 O'Clock

Pipe Material: **Clay** ☐ Pipe Lined

Infiltration: **None** Pipe Seal Cond: **Unknown**
